Manhole Inspection Summary

Manhole # S41G__058MH

Record Plat: **41G** Node: **058** Status: **New Manhole (Not in GIS)** Insp Date: **5/19/08 12:00 AM**

Location Address: **across 1100 pratt st**

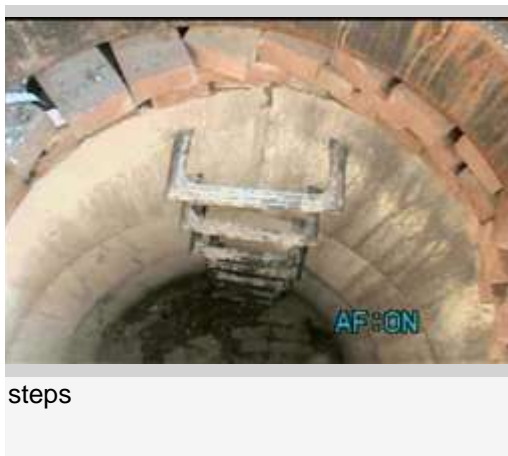
Defect 4

Steps Count: **7** Missing: **0** ☒ **Corroded**

steps

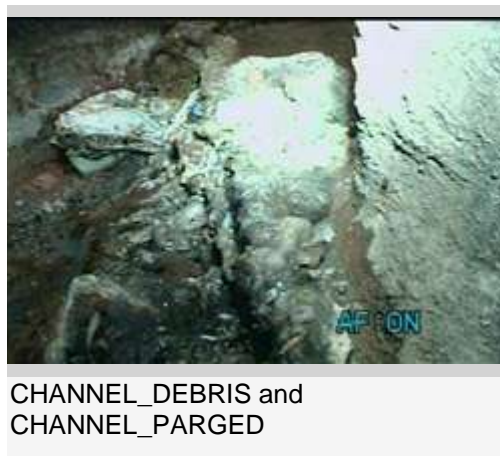
Defect 3

Condition: ☐ Sound ☐ Cracked ☐ Root Intrusion ☐ Deteriorated ☐ Leaks ☒ **Debris**

CHANNEL_DEBRIS and
CHANNEL_PARGED

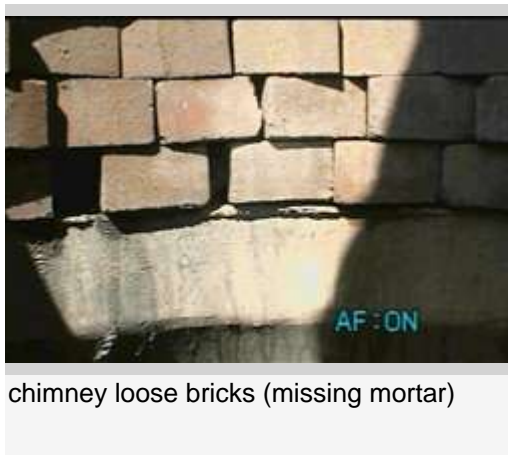
Defect 2

Condition: ☐ Sound ☐ Cracked ☐ Root Intrusion ☒ **Loose Brick** ☐ Deteriorated

chimney loose bricks (missing mortar)

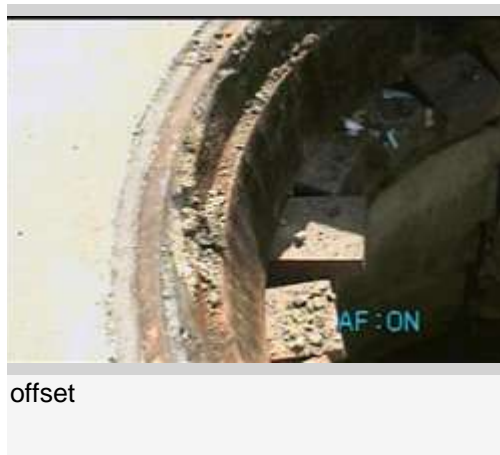
Defect 1

Frame Offset: **5** (in.) Condition: ☒ Sound ☐ Cracked ☐ Leaks

offset

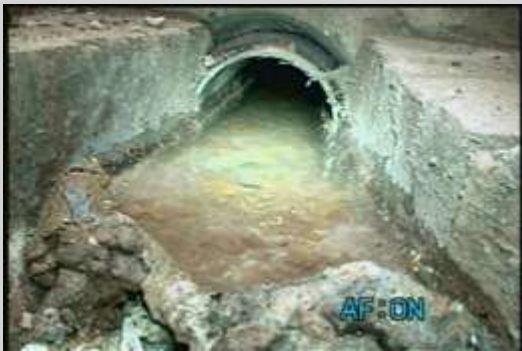
9 O'Clock Inflow

Deposits: ☐ None ☐ Mud ☐ Sludge ☒ **Debris** ☐ Grease

Silt Depth: 2 (in.) Deposits Extent: **Medium**
